### THE EUROPEAN HERITAGE PROJECT RESTORES FACADE OF PALAZZO BELLONI BATTAGIA ON THE CANALE GRANDE

**München/ Venice, 20 August 2020**

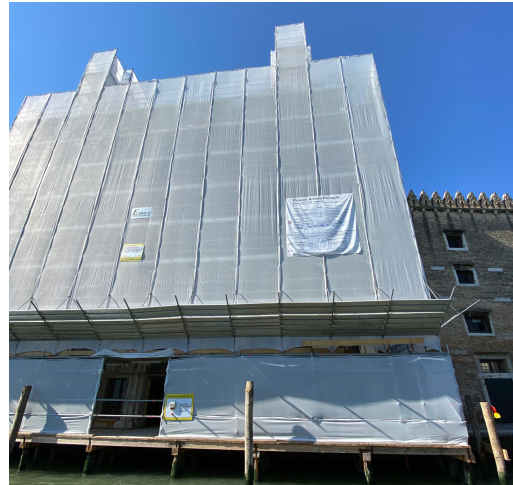
*Scaffolding at Palazzo Belloni Battagia on the Canale Grande – Picture Credit: THE EUROPEAN*

When The European Heritage Project acquired the 17th-century palazzo on the Grand Canal, it was clearly visible that extensive restoration and renovation measures were required to restore the splendour of bygone days. The building has now been completely surrounded by scaffolding to carry out work on the facade.

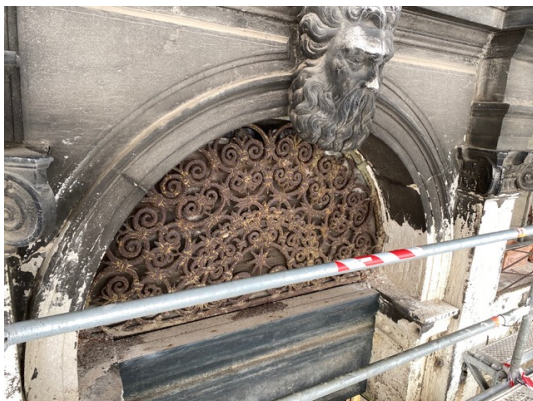
*Window grilles from the 8th century  
Picture Credit: THE EUROPEAN HERITAGE PROJECT*

The elaborately manufactured window grates from the 18th century require extensive restoration. Decades worth of rust has damaged the material and endangers the substance and stability of the ancient cultural artefacts. Missing window grates are to be replaced.

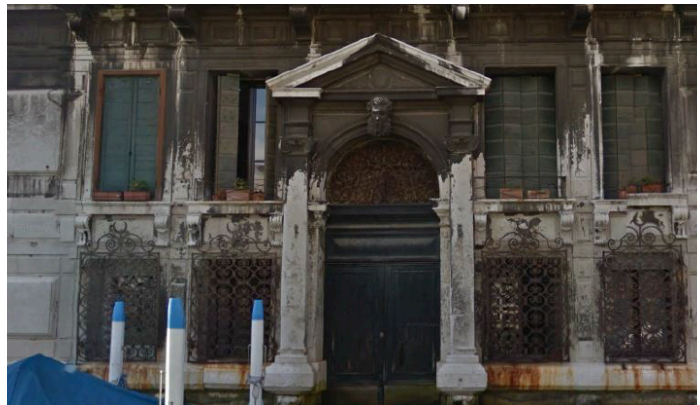
Measurements made in cooperation with the responsible authorities, the Soprintendenza, and the monument preservation authorities, indicated that the entire facade was unstable and was threatening to topple over. Signs of the movement of the building were also visible in cracks in the parquet in the interior of the palazzo. The aim of the restoration measures is to prevent a possible collapse of the building and to save the palazzo, from a static point of view, for coming centuries. In the course of this work, the historical building substance is to be revised and construction sins of the past removed.

*Current state of the façade*

Modern window shutters attached to the facade in the past, for instance, are to be removed and replaced with new ones corresponding to the historical model. Brittle stone elements characterising the appearance of the facade, are to be extensively restored and supplemented.

After the completion of all restoration measures in November, the facade will be cleaned thoroughly. This will have a significant effect on the appearance of the palazzo, since the once gleaming white facade has turned black over the years due to exhaust gases and weather influences.
